# AIRCRAFT ACCIDENT REPORT

UNITED AIR LINES, INC.

Boeing 737, N9031U

REPORT NUMBER: NTSB-AAR-73-16

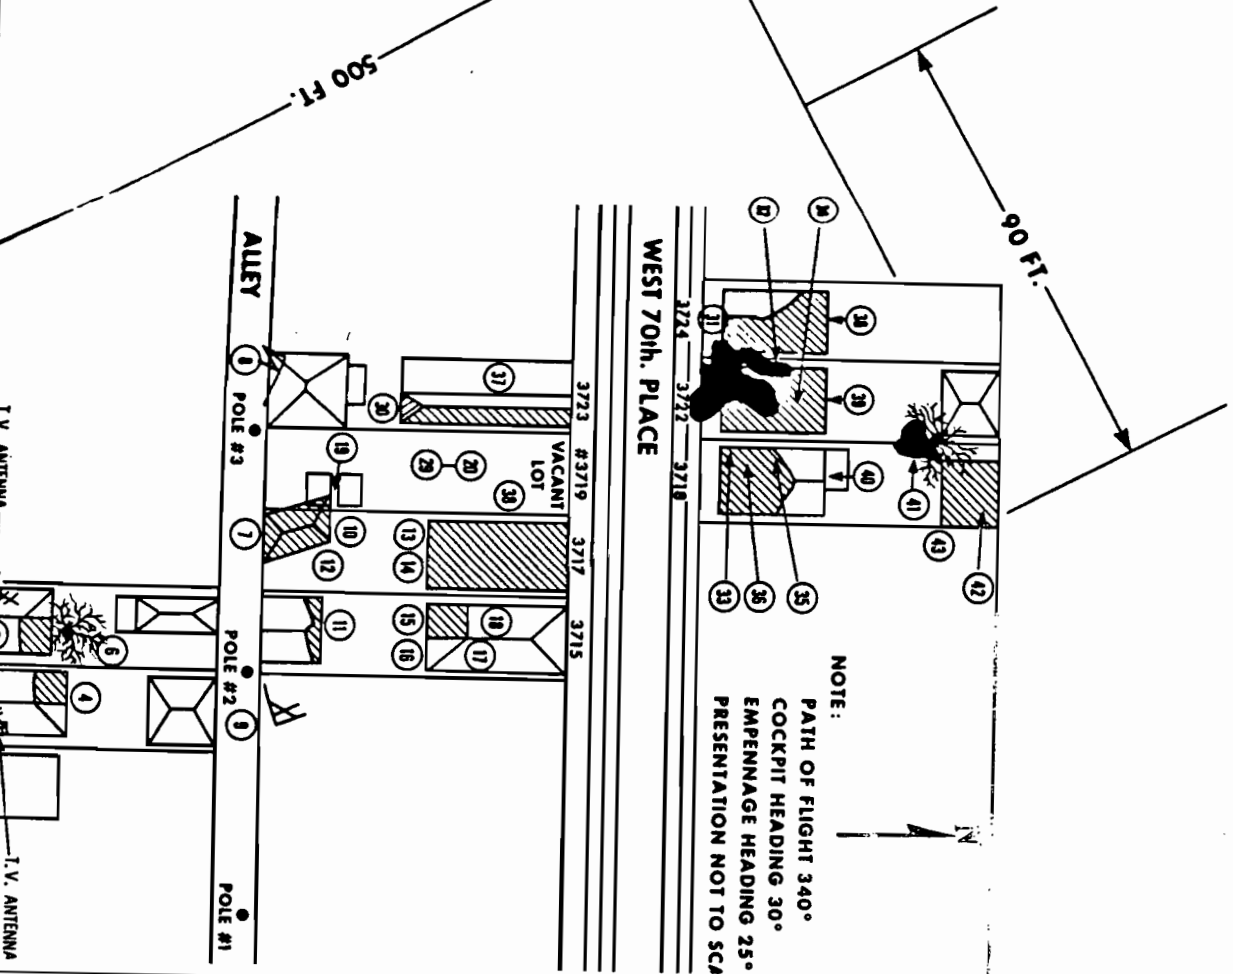
- 17 SOUTHWEST CORNER OF HOUSE DAMAGED.
  - 18 SECTION OF RIGHT WING LEADING EDGE FOUND BETWEEN HOUSES.
  - 19 SECTION OF LEFT HORIZONTAL STABILIZER.
  - 20 SECTION OF FLAP TRACK INCLUDING JACK SCREW.

- 21 SECTION OF FLAP TRACK FAIRING.
